# KELVIN POWER STATION: IWUL EXTERNAL AUDIT REPORT 2024

| Title | Kelvin Power Station: Integrated Water Use<br>Licence External Audit 2024 |
| Reference Number | DCC/IWUL-A_KPS/12/24 |
| Date | December 2024 |

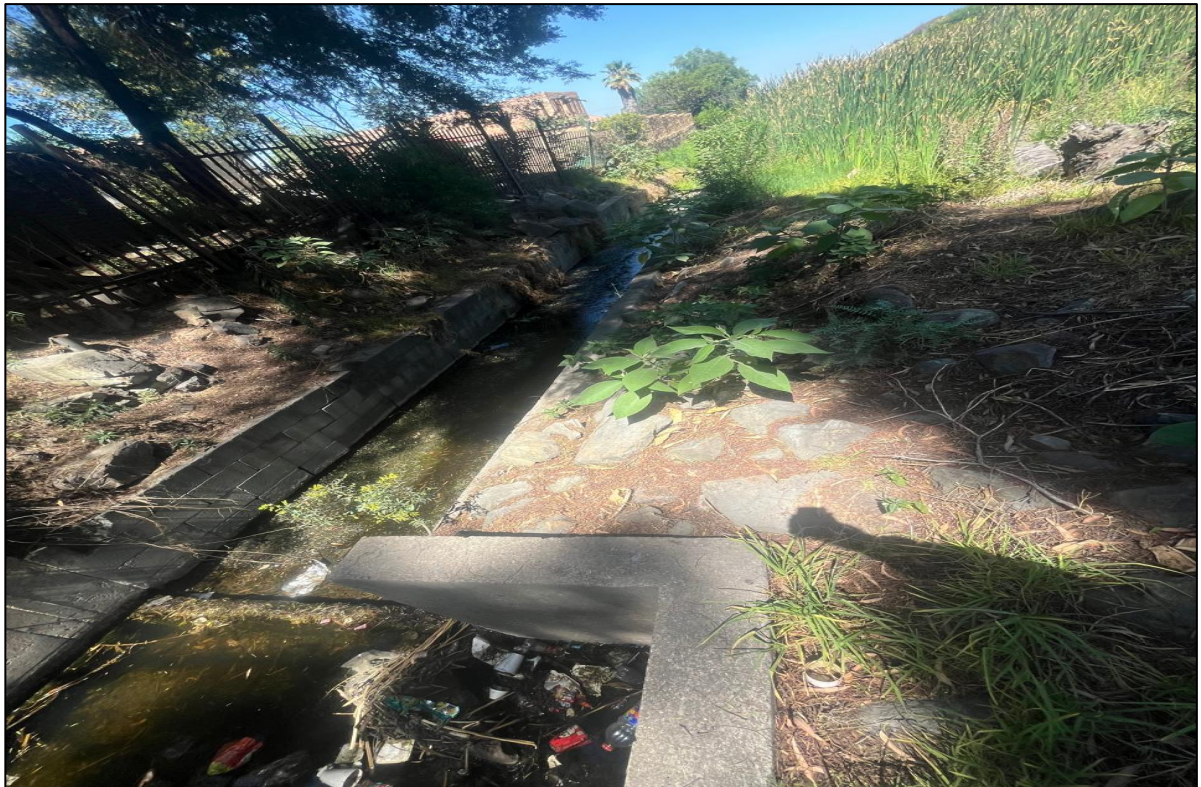
Site Photo 1: showing the secondary channel.

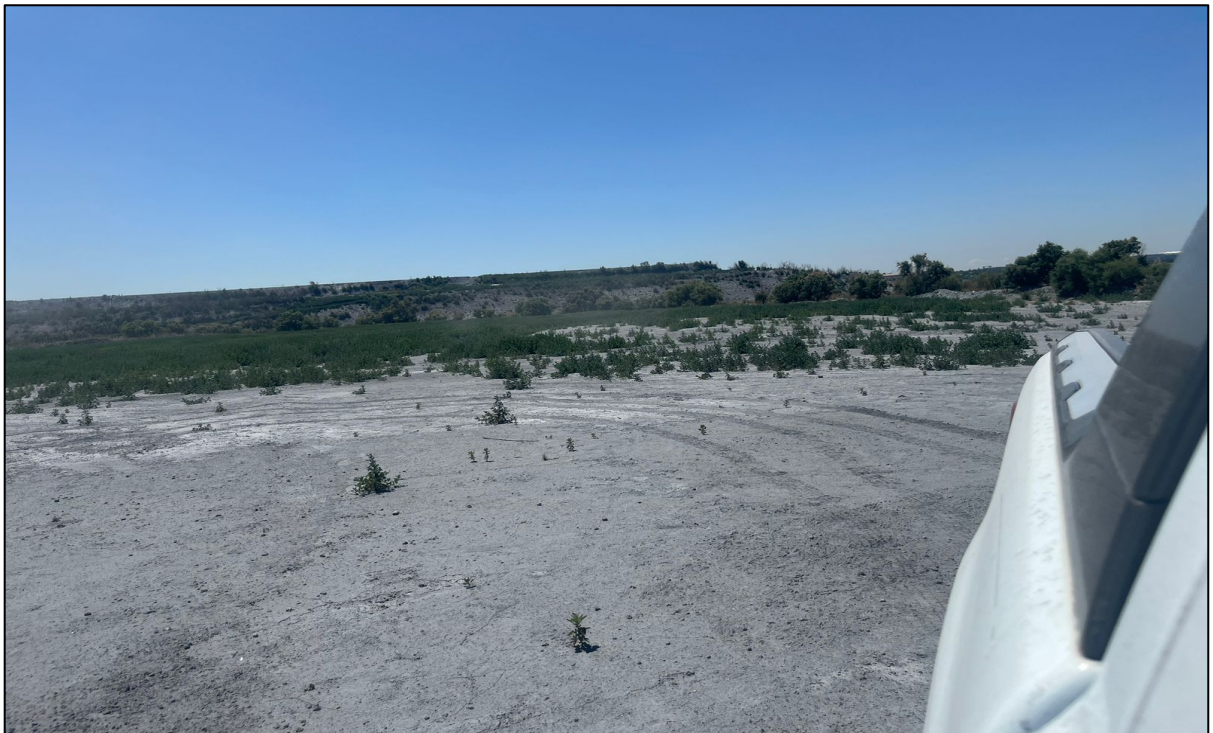
Site photo 2: Showing ash dam A.

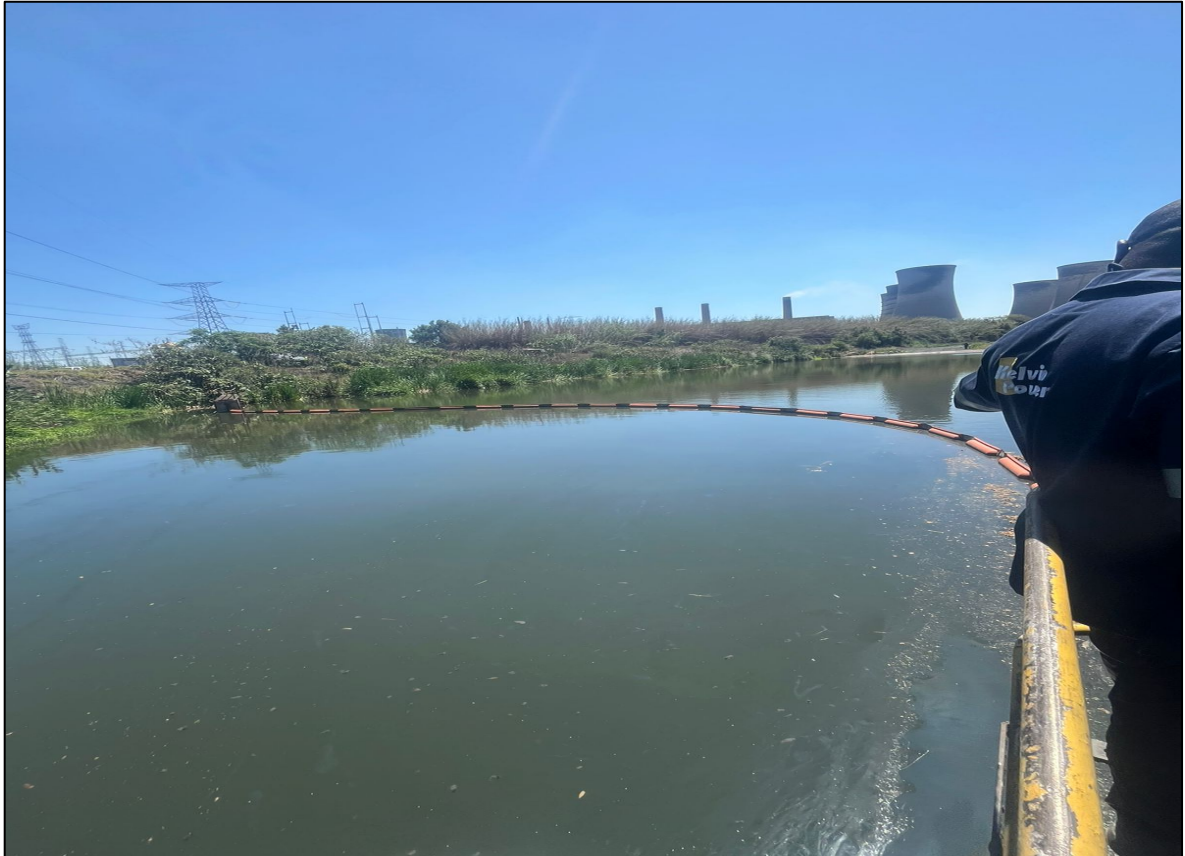
Site photo 3: Showing de-silting dam

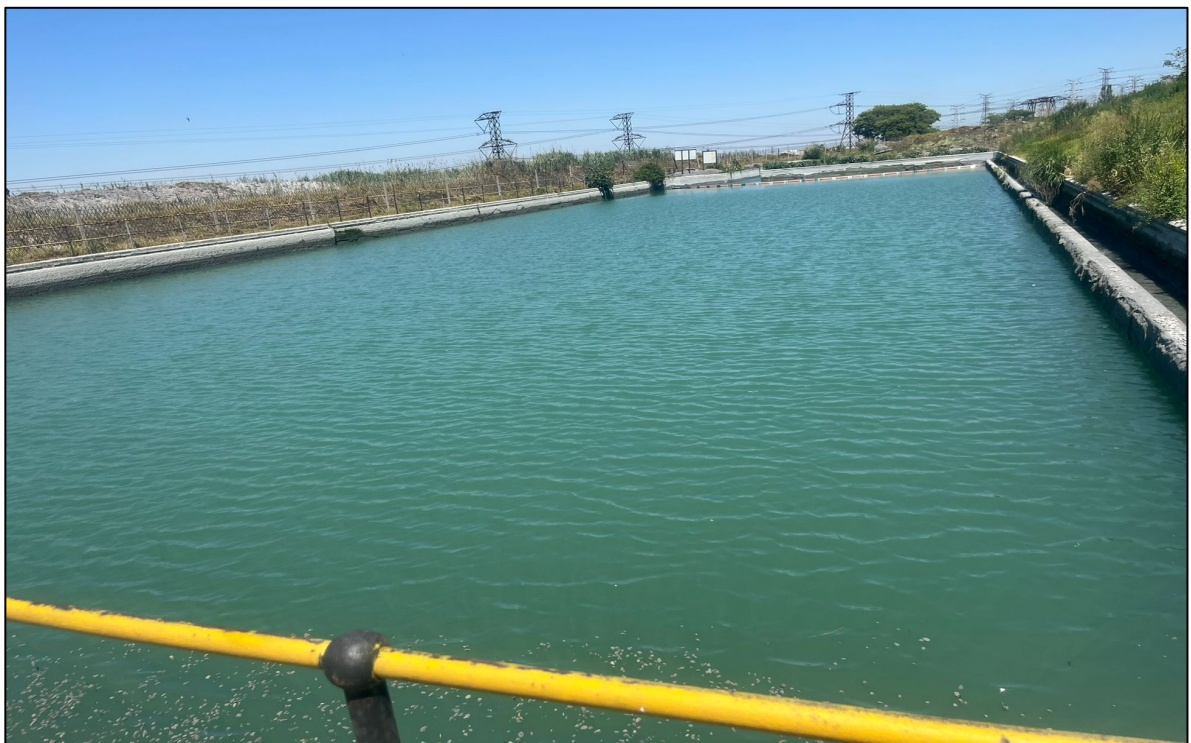
Site Photo 4: Showing the return dam

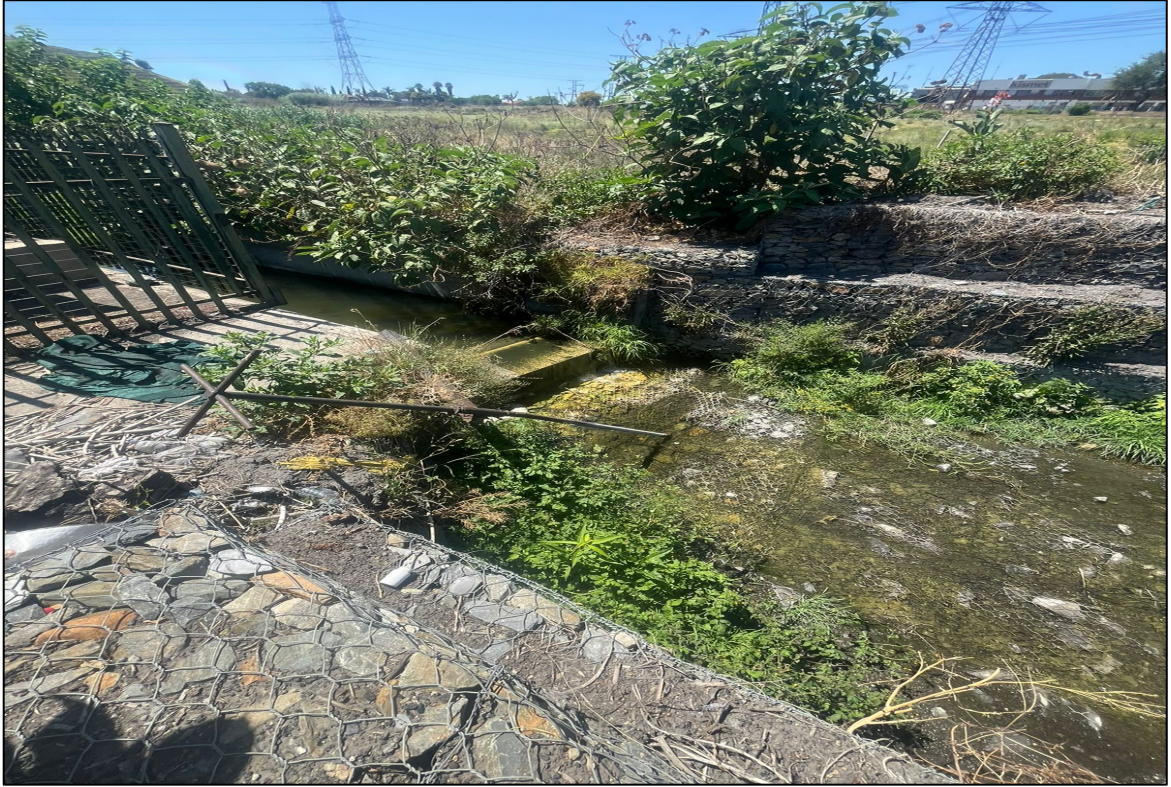
Photo site 5: Showing downstream point to Modderfontein Spruit river.

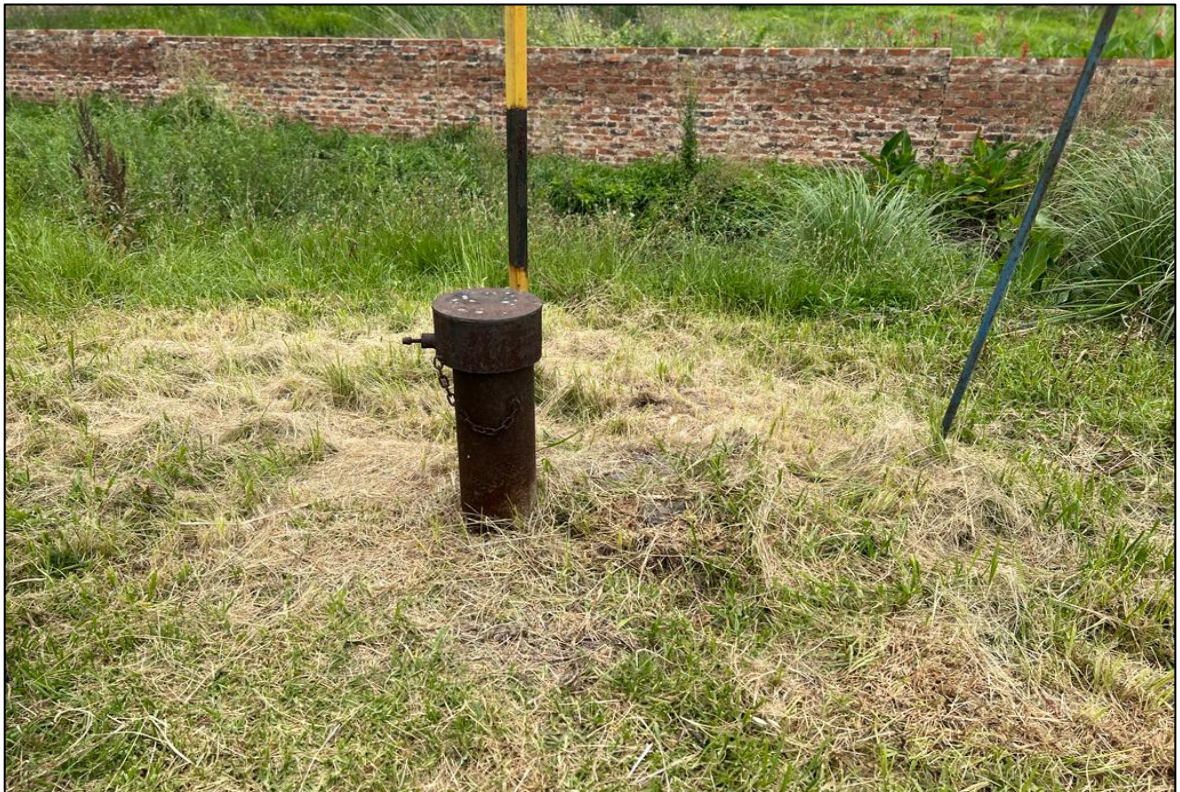
Site photo 6: Showing a borehole.

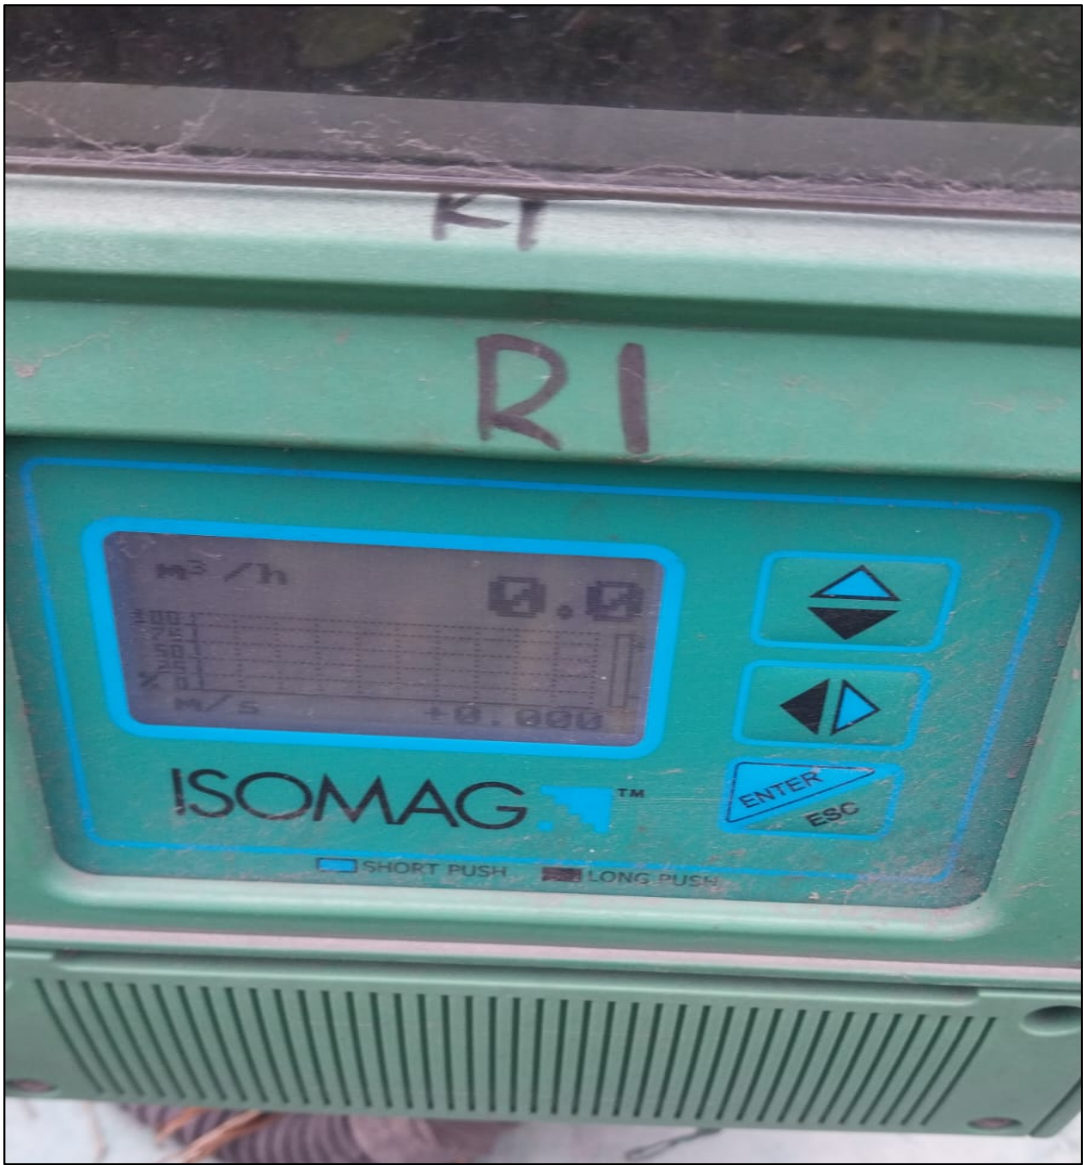
Site Photo 7: Metering Devices across the facility.
