ANNUAL EXTERNAL WATER USE LICENCE AUDIT REPORT - 2024 MOOPLAATS COLLIERY

IWUL NO: 08/C11B/AGJ/2141
FILE NO: 16/2/7/C112/C155

EIMS REFERENCE: 1656
DOCUMENT TITLE: ANNUAL EXTERNAL IWUL AUDIT REPORT – 2024
MOOIPLAATS COLLIERY (MPC)

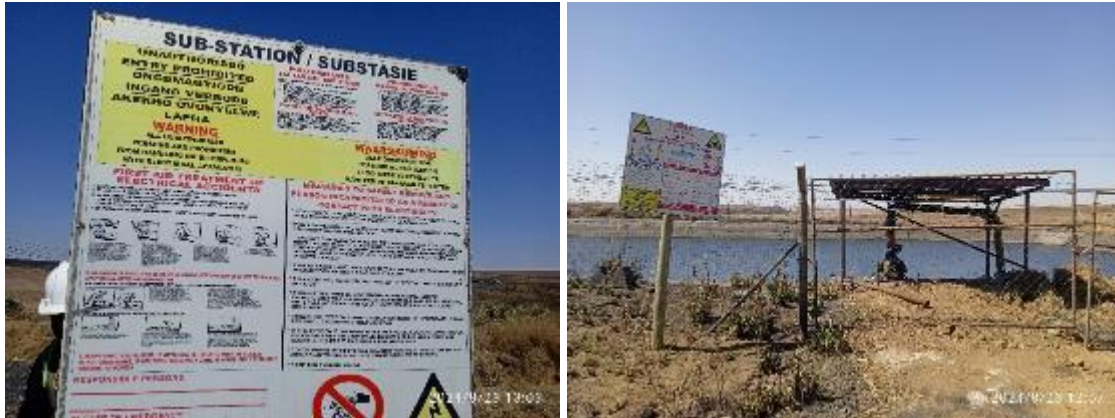
Figure 4: Acceptable signs indicating the risks involved in case of an unauthorised entry observed at the wastewater dams at the entrance gate.

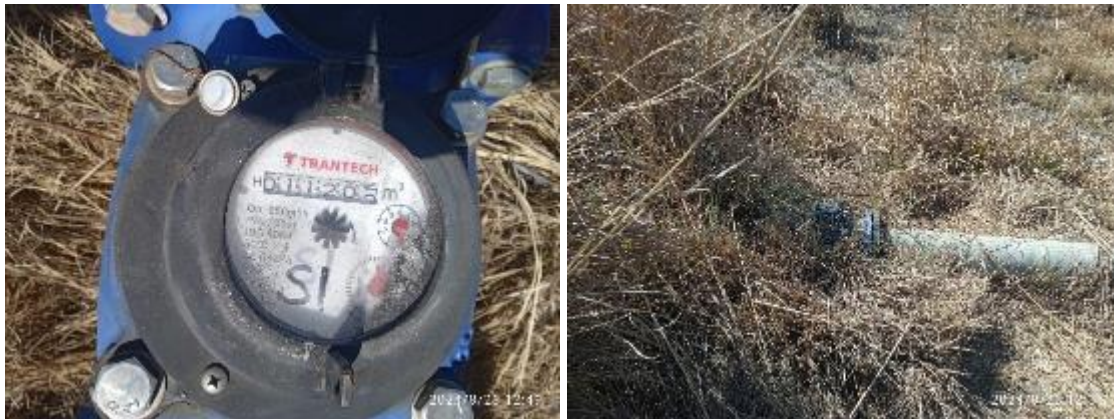
Figure 5: Flow meters observed in a good condition. The readings are recorded by the mine staff.

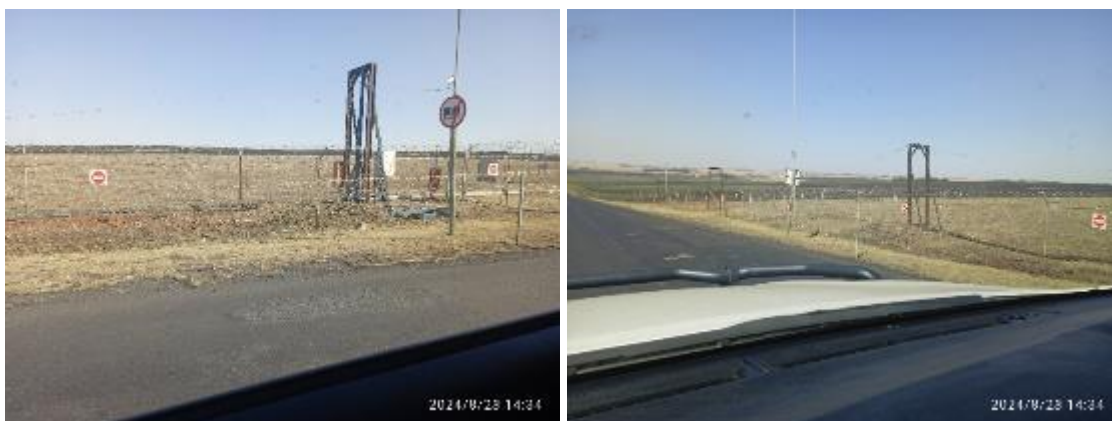
Figure 6: View of Usuthu boreholes supplying water to site.

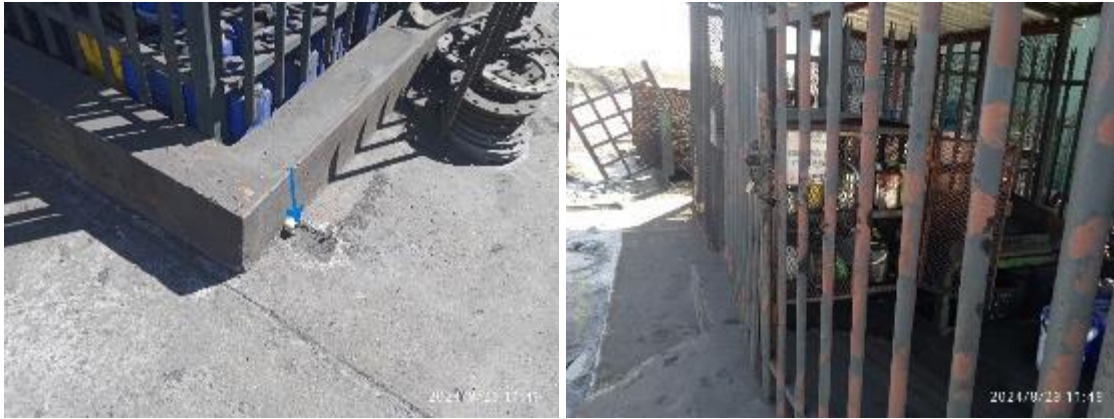
8.2	All reagent storage tanks and reaction units must be supplied with a bunded area built to the capacity of the facility and provided with sumps and pumps to return the spilled material back into the system. The system shall be maintained in a state of good repair and standby pumps must be provided.	2	No specific reagent storage tanks and reaction units were noted at the Colliery. However, one of the bunded area required a plug on the draining pipe that was open posing risk of pollution in the event of a spill.

Figure 7: The hazardous storage cage bunded area required a plug on the draining pipe that is open to reduce risk of possible spills to the environment (left picture) and lacks relevant signs (right picture).

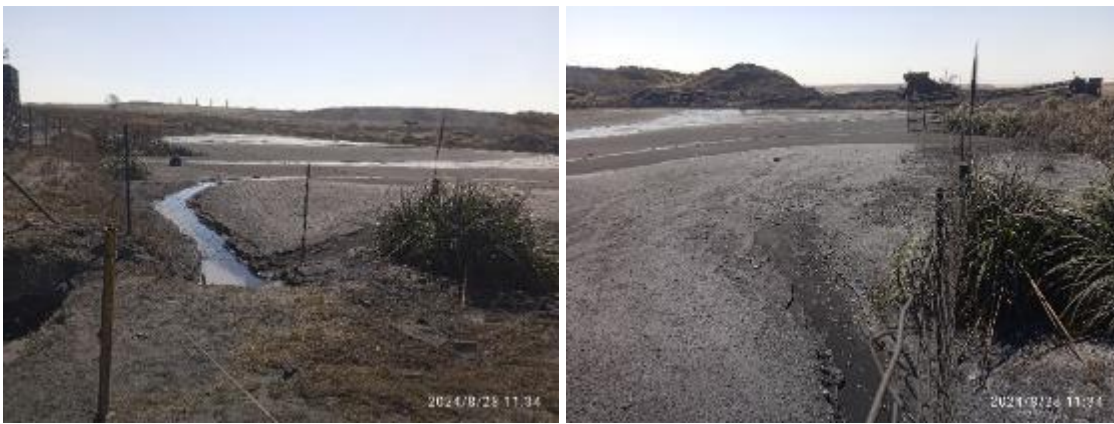
IWUL Ref #	Condition	Compliance Rating	Comments/ Verification
			stormwater management control measures thereby posing potential pollution to the environment. Refer to Figure 8 and Figure 9.

Figure 8 The silted wash plant PCD.

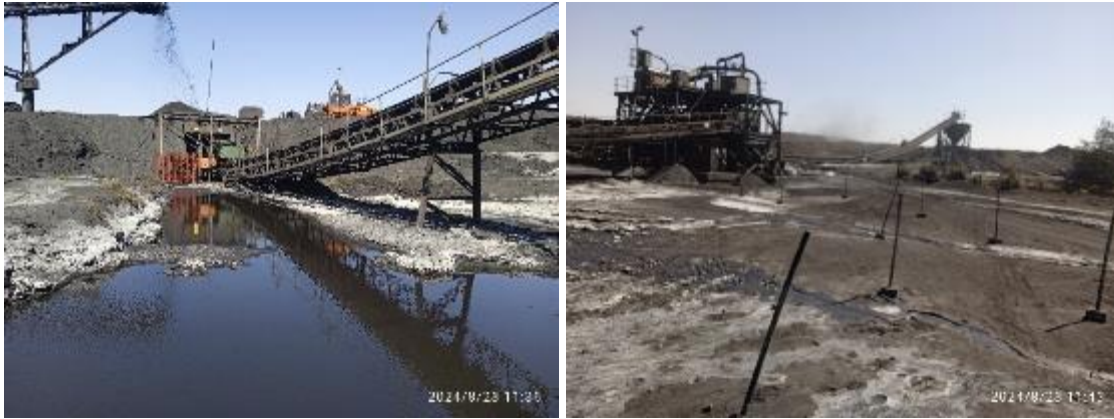
1.4	The Licensee must ensure that the disposal of the waste and water containing waste and the operation and maintenance of the system are done according to the provisions in the WUL Report.	0	During the site visit, the operation and maintenance of the waste containment facilities was considered inadequate as run-off water from the plant was flowing to the environment. The plant PCD is silted, vegetation growing and overflowing into the environment. Refer to Figure 9.

Figure 9: Potentially contaminated run-off water from the wash plant by passing the silted PCD and flows to the wetland.

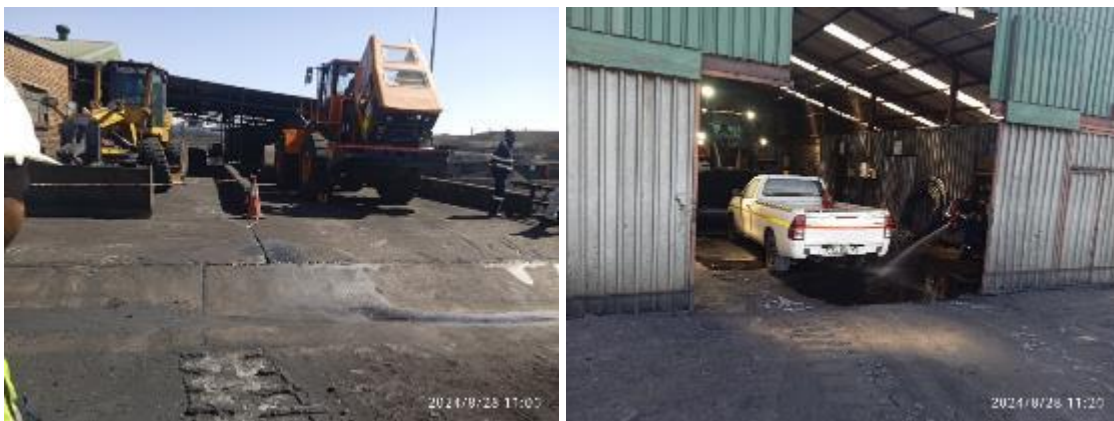
Figure 10: View of workshop impervious surface and drainage and car washing activity with potential to pollute the environment

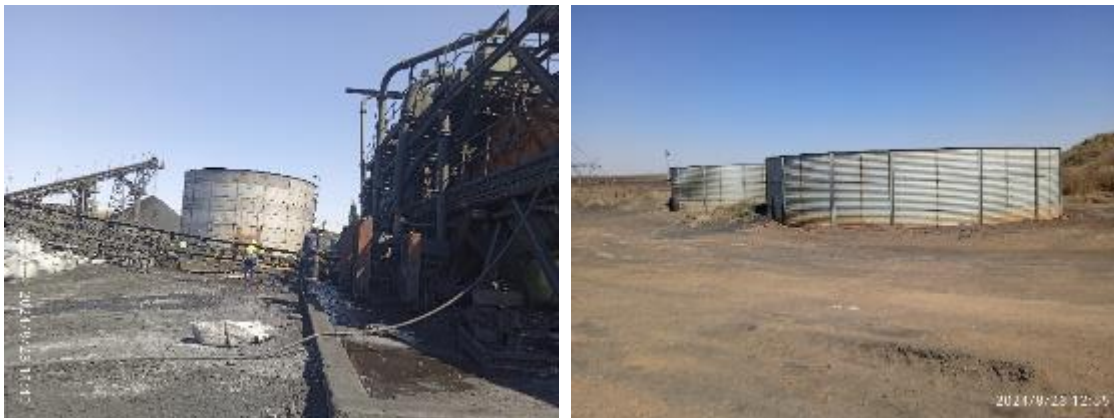
Figure 11: View of Erickson dams at the wash plant (left picture) and decommissioned ones adjacent dam 1 (right picture refer to Figure 2 - 36).

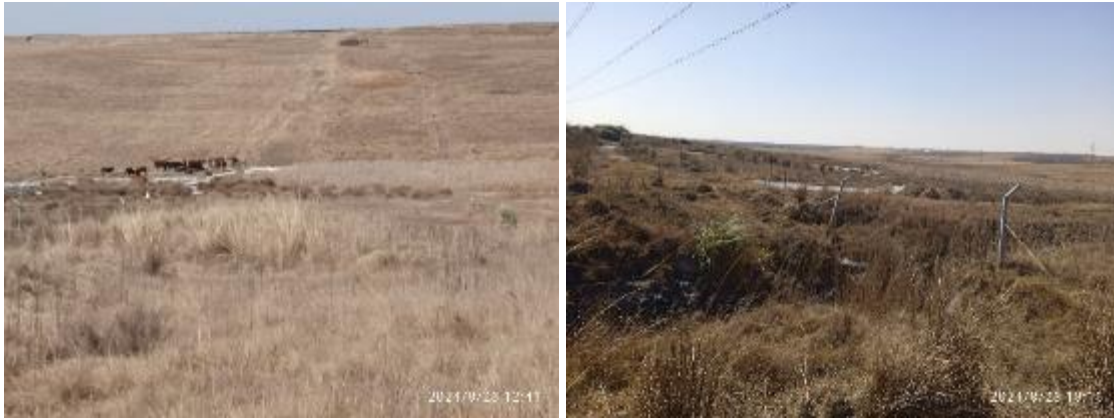
Figure 12: Traces of MPC pollution risk to the environment due to inadequate stormwater management on site.

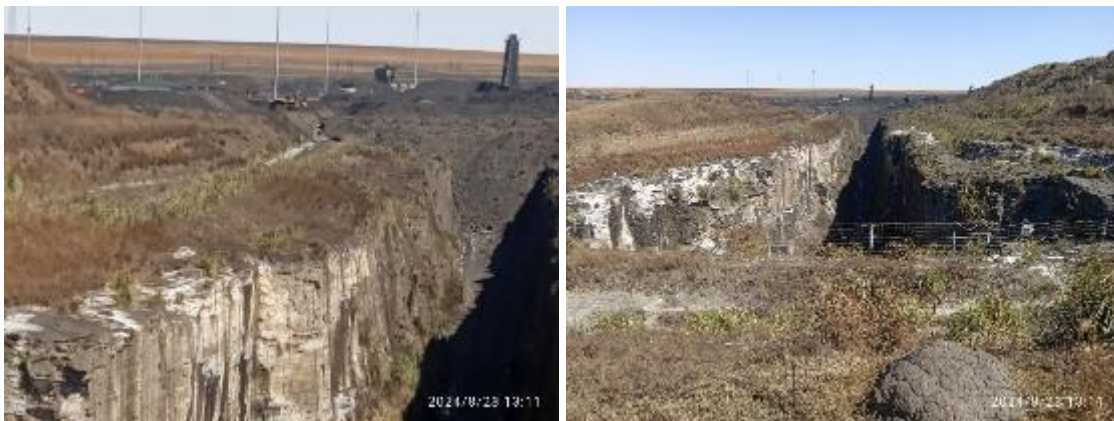
Figure 13: Underground operations ceased end of 2021 and back filling has commenced as part of rehabilitation.

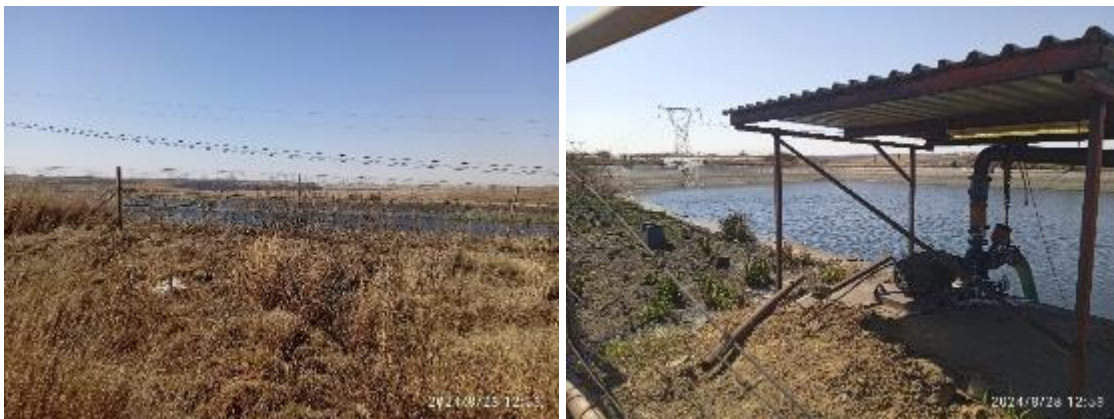
Figure 14: Co-disposal Dam 3 and Dam 1.

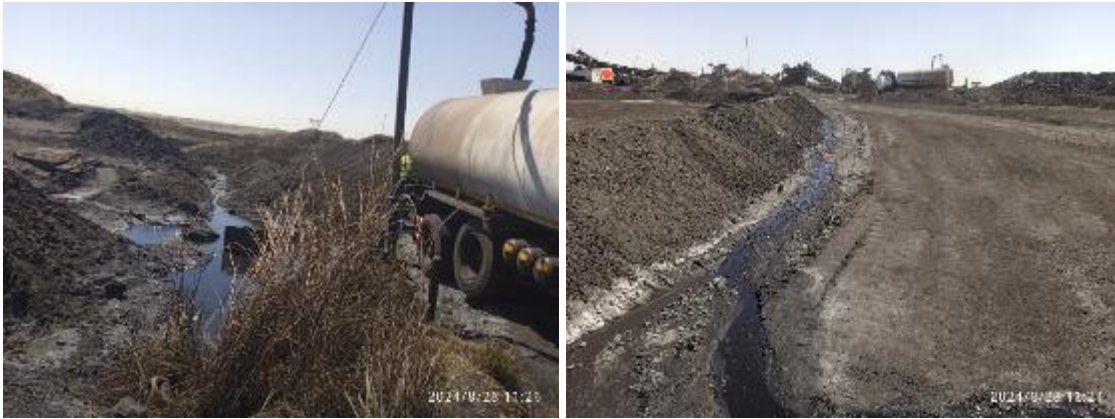
IWUL Ref #	Condition	Compliance Rating	Comments/ Verification
7.1	Storm water leaving the Licensee's premises shall in no way be contaminated by any substance, whether such substance is a solid, liquid, vapour or gas or a combination thereof which is produced, used, stored, dumped or spilled on the premises.	0	Process water from plant, gooseneck for dust suppression, and potential seepage from the holding trench located on the eastern side of the substation was observed discharging into the wetland. Traces of contaminated water from the weighbridge was observed flowing through the stormwater channel at the admin offices carport discharging into the wetland. More so, visual observation of traces of seepage potentially from the co-disposal facility on the northern-western side of the facility. This has potential to impact the Witpuntspruit from upstream (WT-S01) to downstream (WT-S06) if no interception of seepage is undertaken. However, it was reported that a consultant was appointed to compile a stormwater management report for the MPC site (PO109500 dated 14 June 2024). Refer to Figure 15

Figure 15: Uncontrolled flow of contaminated water from the goseneck towards the wetland.

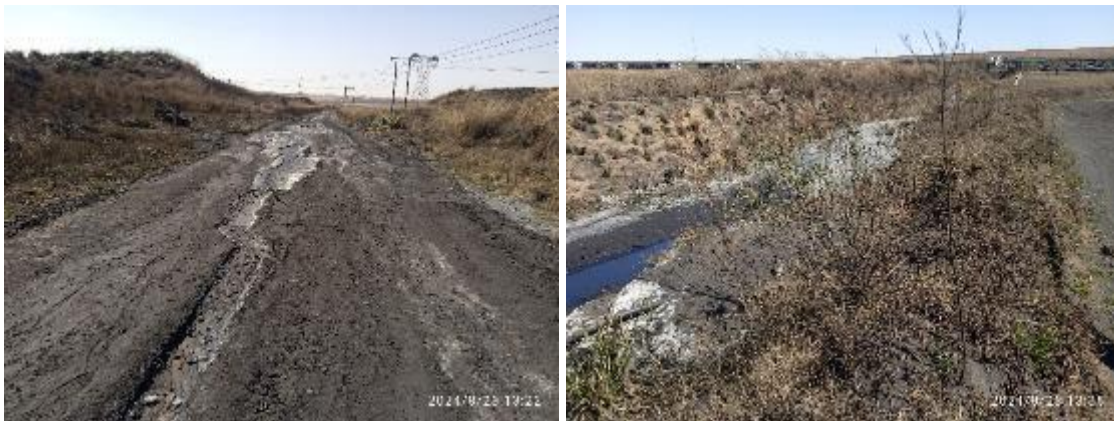
Figure 16: Uncontrolled flow of contaminated water from site towards the wetland.

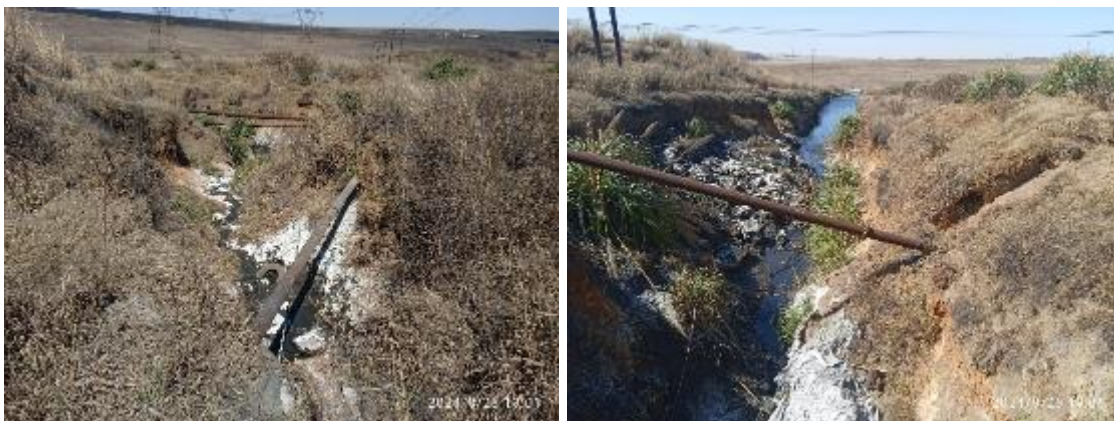
7.2	Increase runoff due to vegetation clearance and/or soil compaction must be managed, and steps must be taken to ensure that storm water does not lead to bank instability and excessive levels of silt entering the stream.	0	Significant erosion was noted within the clean stormwater channel at the offices. No evidence of erosion control measures being implemented. Refer to Figure 17.

Figure 17: Erosion of the channel discharging potentially contaminated stormwater into the wetland on the north-eastern side.

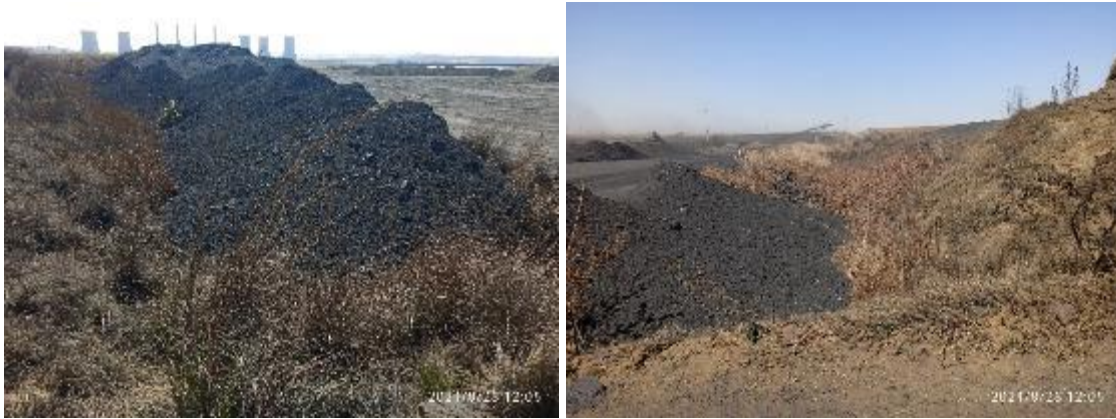
7.5	Storm water control works must be constructed, operated and maintained in a sustainable manner throughout the impacted area.	0	The storm water control works were noted to be compromised with major erosion in the drain at the admin offices carport and adjacent Dam 3 areas. RoM stormwater drains were partially blocked with contaminated soil stockpiles dumped within the channel. No evidence of maintenance or ongoing repairs to this erosion was noted at the time of the audit inspection. Refer to Figure 18.

Figure 18: Discarding of potentially contaminated material onto the stormwater channel along the RoM.

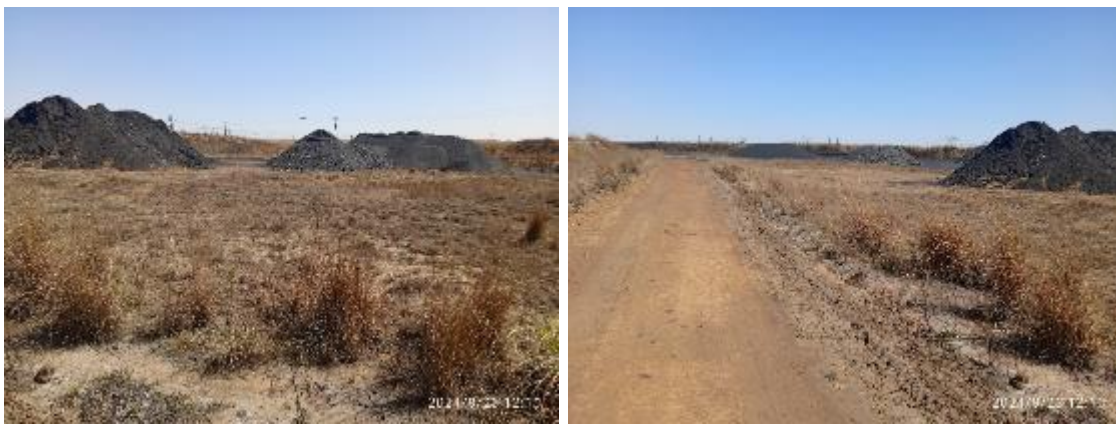
Figure 19 Dumping of carbonaceous material outside stormwater management controls with potential to pollute the environment.

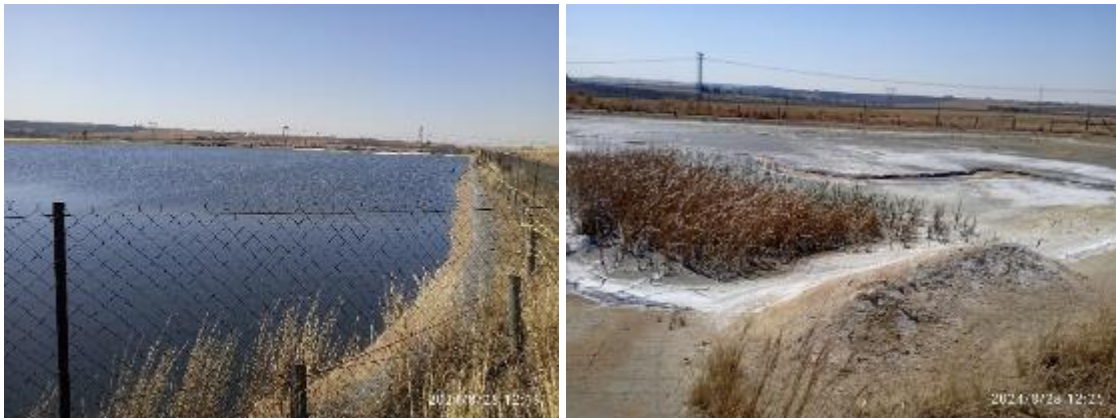
Figure 20: Lined Return Water Dam (34) and poorly maintained silt trap (35) on the northwestern side of Co-disposal facility.

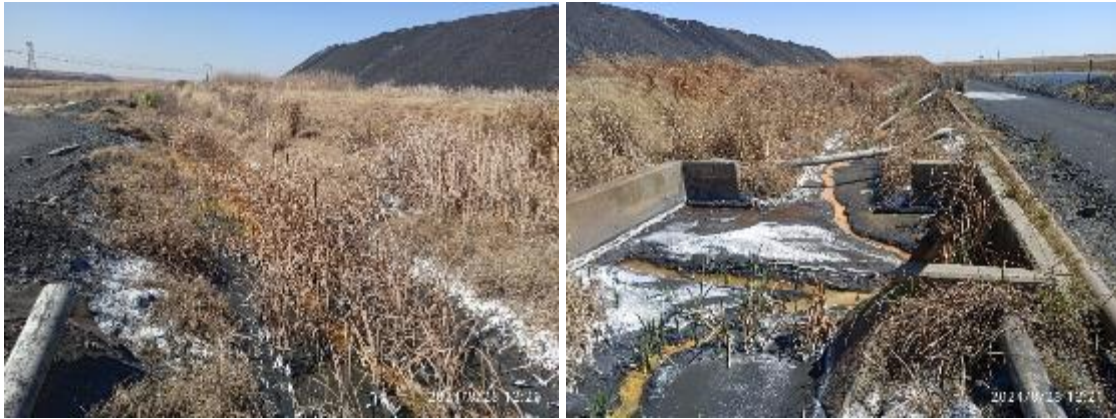
Figure 21: Inadequately maintained north-western drainage system for the co-disposal facility.

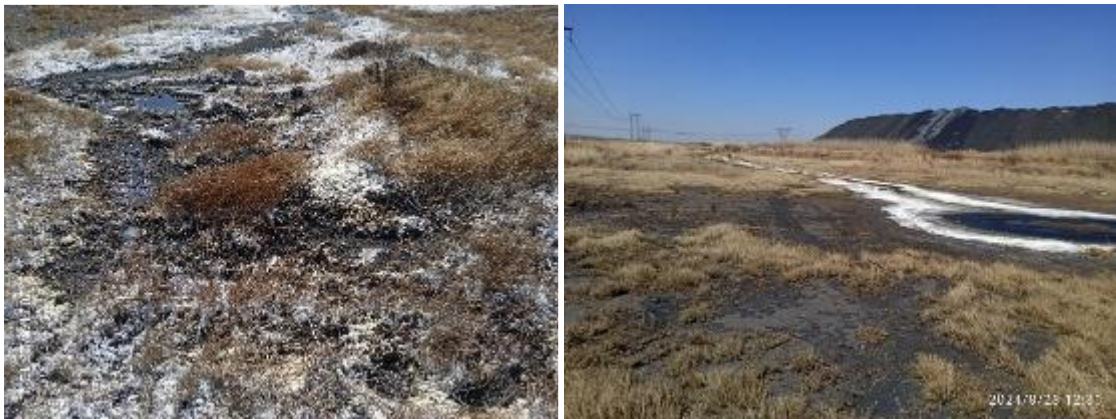
Figure 22: Visual observation traces of seepage potentially from the co-disposal facility on the northern-western side of the facility. This has potential to impact the Witpuntspruit from upstream (WT-S01) to downstream (WT-S06) if no interception is undertaken.
