Vegetation and Wetland Assessment for the pipelines, pump station and product staging area at Sibanye Stillwater

June 2023

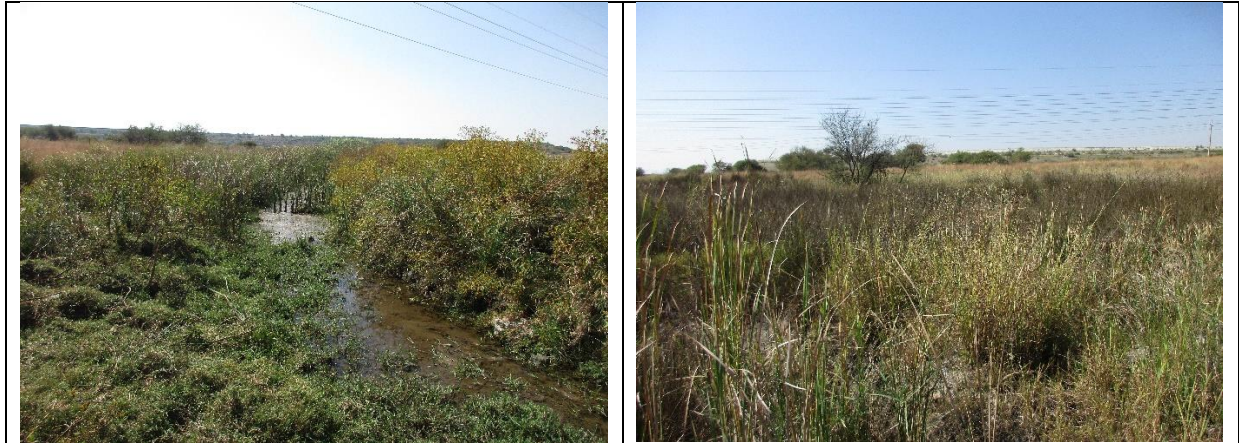
The natural and artificial wetland areas on site have a very similar species composition. The wetland areas are mainly dominated by *Cyperus sexangularis*, which often forms a monostand in the wetland areas. Several other sedge species and other wetland species are also present in lower dominance, mainly along the outer edges of the wetland areas and along road crossings. The proposed pipeline and powerline crossings are therefore mainly located along the edges with a greater species diversity. In the artificial seep wetland areas, a wider zone of grass and forb species are present and the dominance of *Cyperus sexangularis* is lower. The vegetation diversity in both the natural and artificial wetland units are low.

Figure 7: Vegetation in one of the natural (left) and artificial (right) wetland areas.

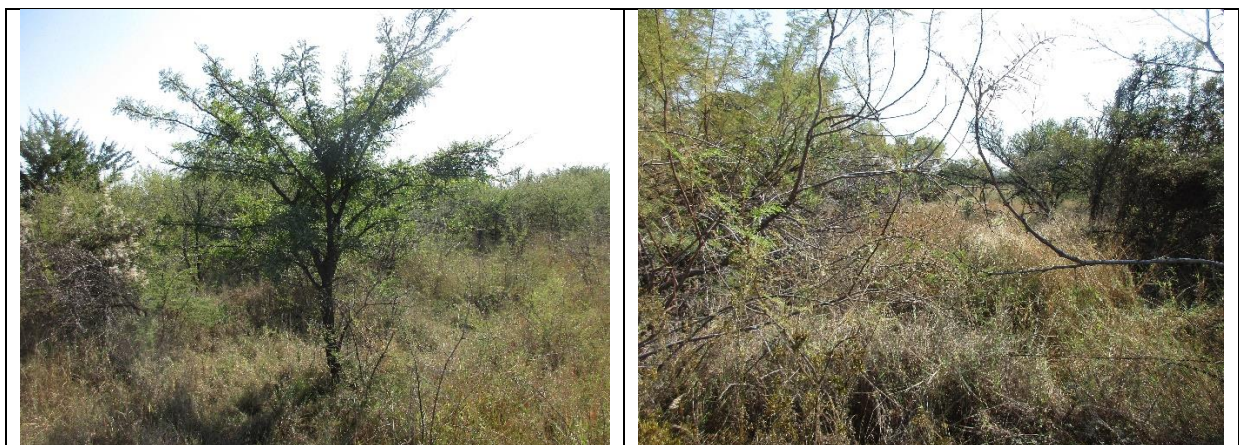
The Marikana Thornveld vegetation unit most closely resembles the Marikana Thornveld vegetation type as described in Musina and Rutherford (2006). Although this vegetation unit has the second highest species diversity, most of it indigenous, the diversity is relatively low. The low diversity may be due to the season of the site assessment, or the relatively small area visited. A greater diversity of forbs and geophytes are expected earlier in the growing season. The low species diversity may also be a function of the high grazing pressures in the area. Only a small section of Marikana Thornveld vegetation unit is affected by the proposed activities, with the vegetation unit only present at the proposed stockpile pad and loading area.

Figure 8: Images of the Marikana Thornveld vegetation unit (left) and the Modified Marikana Thornveld vegetation unit (right).

The Modified Marikana Thornveld vegetation unit has a higher species diversity than the Marikana Thornveld vegetation unit, mainly due to the higher number of alien and invasive plant species. This vegetation unit is present in areas where some disturbance took place in the past, including ploughing or heavy grazing, and the vegetation has recovered to resemble the Marikana Thornveld vegetation type, but with several indicators of disturbance present. Indicators of disturbance include

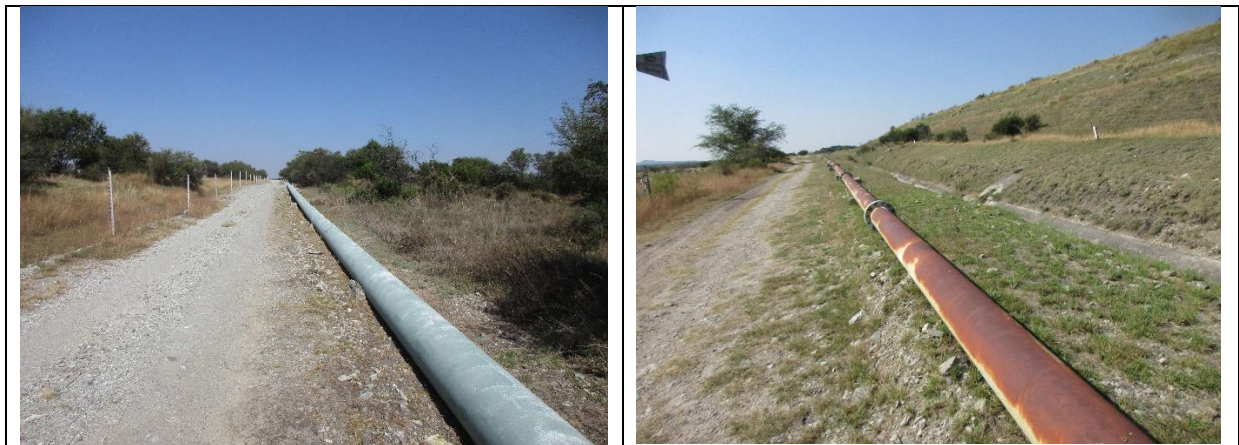
Numerous disturbances are present in the area, mainly associated with the mining activities. This includes existing dams and pump stations, several pipelines and powerlines, roads, tailings facilities, clean water canals and other infrastructure. These disturbances result in patches bare of vegetation and allow for the establishment of pioneer vegetation in the disturbed areas. Most of the proposed pipelines and powerlines are along disturbed areas, which significantly decreases the impact of the proposed activities on the environment.

Figure 9: Images of the disturbances on site.

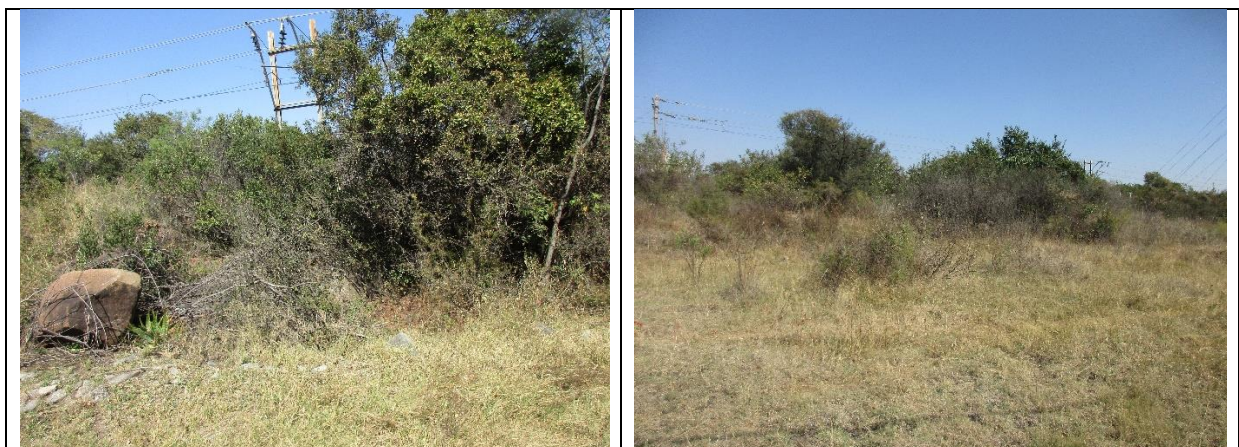
The Rocky Outcrop vegetation type is less common in the area and is present along the proposed New Access Route 1 and in the south-western corner of the Remining and booster pump area. The soil in these areas is very rocky and more sandy, as opposed to the dark turf present throughout the rest of the site. These areas have a greater woody component, with a small herbaceous component. The species observed in the unit is fairly common and widespread and nothing of particular conservation importance were noted.

Figure 10: Images of the Rock Outcrop.

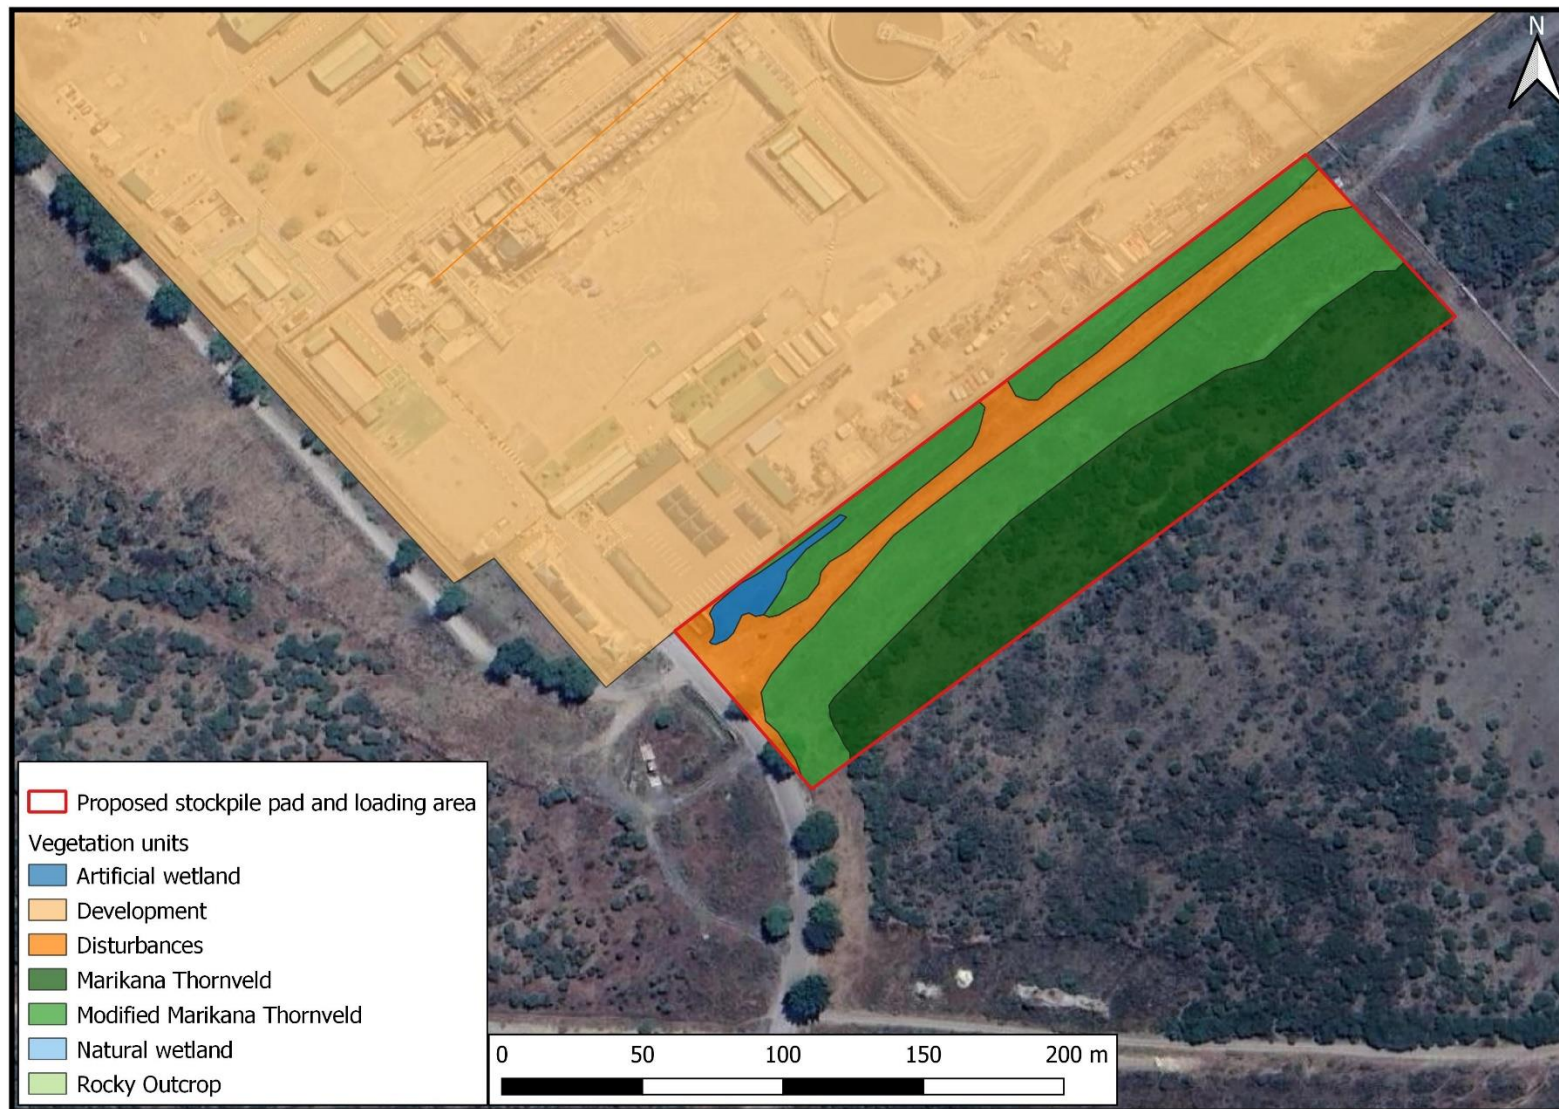
Figure 15: Vegetation units present at the proposed stockpile pad and loading area.
